NEW MEXICO  
ENVIRONMENT DEPARTMENT

**Memorandum**

**Subject:** Pre-CERCLIS Screening Assessment of the F-33 Mine Site, Ambrosia Lake Mining  
District, Cibola County, New Mexico: Further Investigation under CERCLA  
Recommended

<b>Site name</b>	F-33 Mine (NM0057)	<b>Street address</b>	Not Applicable	<b>Zip code</b>	Not Applicable
<b>City</b>	Not Applicable	<b>State</b>	New Mexico		
<b>County</b>	Cibola County				
<b>Latitude</b>	35°12'59.25" N	<b>Longitude</b>	107°46'55.41" W

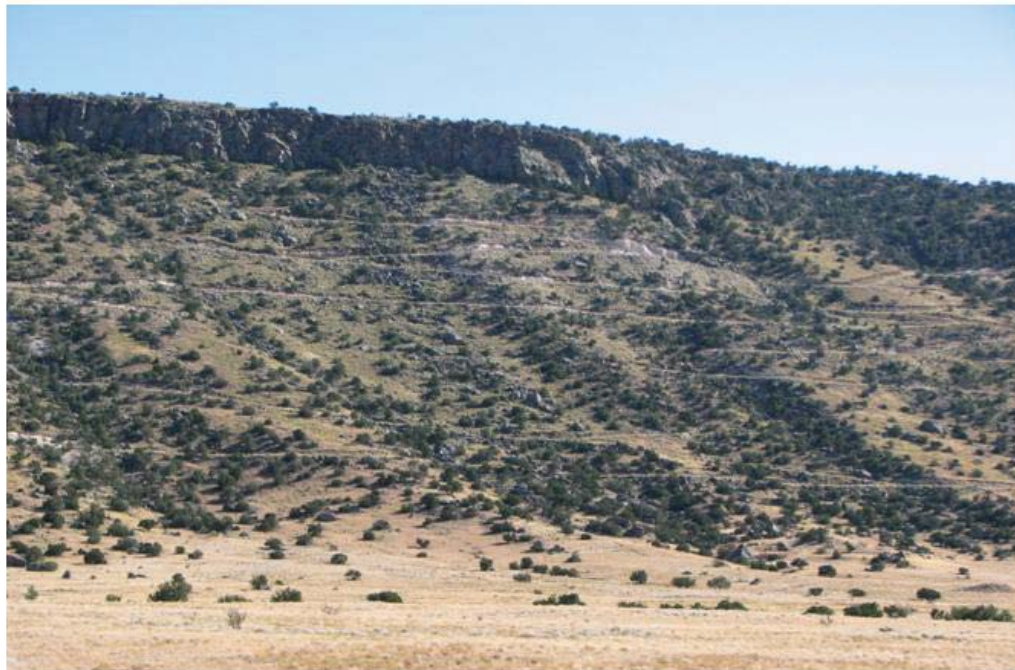
**Photo 1:** Southeast view toward the northwest slope of East Grants Ridge and the F-33 Mine Site that is reached via several switch-back turns on the access road that ascends the ridge.

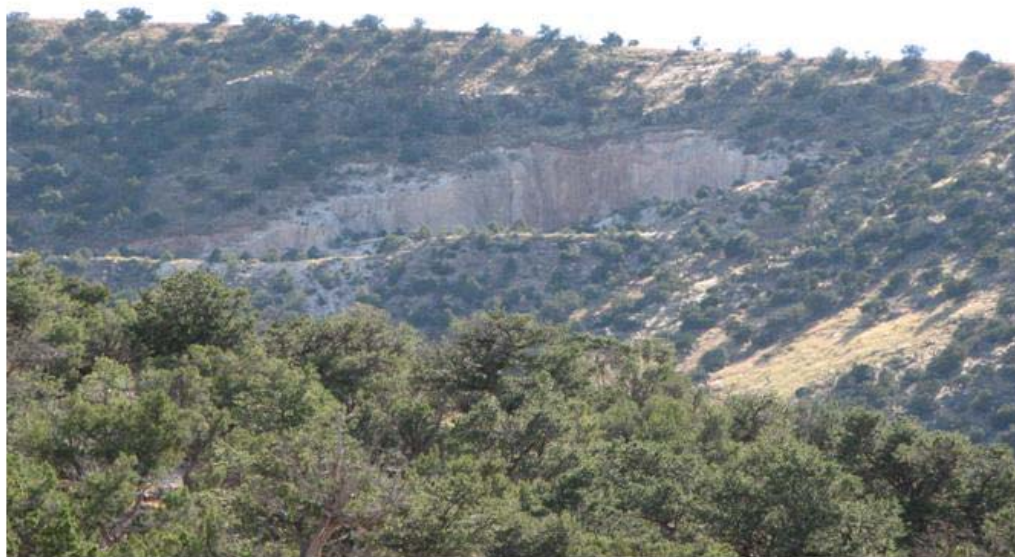
**Photo 2:** Southeast view (zoomed-in) toward the F-33 Mine Site near the top of East Grants Ridge.
